Supporting Information for "High Resolution Multi-Modal Chemical Imaging Platform for Organics and Inorganics"

Spatial resolution of the HIM-SIMS using the BAM-L200 sample

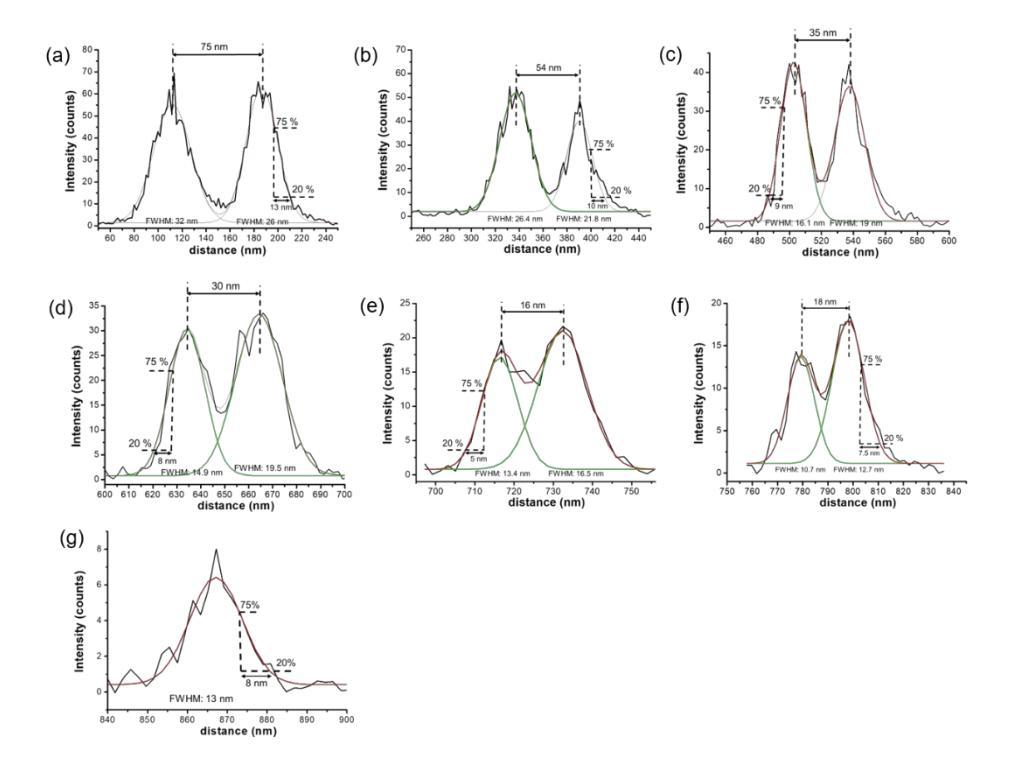
Figure S1. Gaussian peak fitting results for chemical imaging signals of the BAM-L200 reference sample to estimate spatial resolution of the HIM-SIMS for period grating of (a) 76.5 nm, (b) 57 nm, (c) 42 nm, (d) 31 nm, (e) 23 nm, (f) 17.5 nm and (g) the stripe width of 3.5 nm.

In Fig. 1a, we show a chemical image of the BAM-L200 reference sample material to evaluate spatial resolution of the HIM-SIMS. In the chemical image, the peaks of each period grating were analyzed through the Gaussian peak fitting using Origin Pro Version 8.0, as shown in Fig. S1.

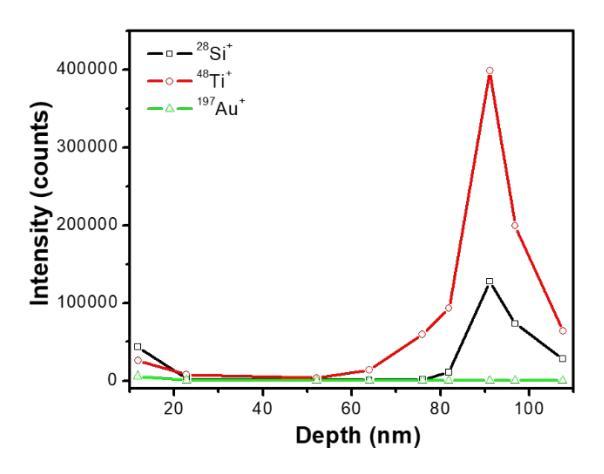
Figure S2. Depth profiling of the gold electrode with a titanium adhesion layer on the SiO_2/Si substrate with a linear scale of y-axis.

Figure S2 shows the depth profiling result of Fig. 1b in a linear scale of y-axis. Figure S3 shows chemical and surface topography images measured for depth profiling of a gold electrode with a titanium adhesion layer on a SiO₂/Si substrate. Three detectors were used to collect the chemical images of m/z~28 for silicon (Fig. S3(a)), 48 for titanium (Fig. S3(b)) and 197 for gold (Fig. S3(c)). Silicon and titanium have the overlapped signals from hydrocarbon contamination, and thus, weak signals at the top surface of the

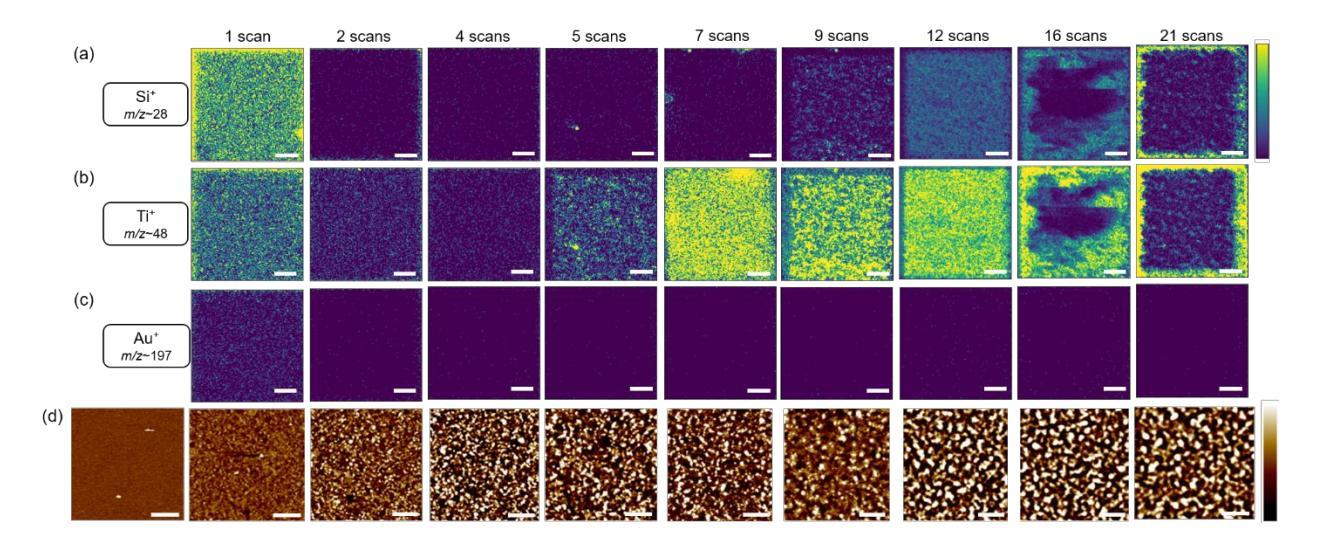
Figure S3. Change of the chemical images of (a) Si⁺ ($m/z\sim28$), (b) Ti⁺ ($m/z\sim48$) and Au⁺ ($m/z\sim197$) with (d) the corresponding topography images measured using the AFM by increasing the number of scans equivalent to the increase of total exposure time (52.4 s/scan). While that of gold chemical images was fixed as 0~1250 cps, the color bar scale (unit of counts per second) for silicon and titanium was varied to observe the change of chemical images more clearly: 0~1250 cps from the 1st scan to the 7th scan, 0~2500 cps for the 9th scan and the 21st scan, 0~10000 cps for the 12th scan and 0~7500 cps for the 16th scan. The color bar scale for topography images is from 0 to 20 nm. The scale bar of all the images is 1 µm.

electrode were measured. By increasing the number of scans, the signals of $m/z \sim 28$ and 48 decreased since the hydrocarbon contaminants were removed by neon ion milling. At the same time, the gold signal at $m/z \sim 197$ decreased and at the 5th scan, the titanium signal appeared locally due to the spatial variation of a sputtering rate of gold, as seen in the topography images in Fig. S3(d). The root-mean-square (rms) roughness of the sputtered area increases upon the consecutive sputtering as shown in Fig. S4(a). An initial rms roughness of the gold electrode was measured 0.6 ± 0.07 nm, but after the 1st scan, the surface roughness increases to 2.1±0.2 nm with the sputtered depth of 11.8±1.7 nm. Continuing sputtering of the electrode resulted in the increase of the surface roughness to 7.8±1.3 nm (64±5.0 nm) at the 5th scan. Since the sputtering yield of gold is larger than titanium, more gold was sputtered out rather than titanium which finally reduced the surface roughness and the overall sputtering rate (slope of the plot in Fig. S4(b)) after the 5th scan. After the 9th scan, the silicon signals started to be measured at the depth of 82±5.0 nm with the surface roughness of 5.5±1.6 nm. After the most of gold was removed, the sputtering rate remained constant and the surface roughness again increased upon sputtering since the sputtering yields of silicon oxide and titanium are similar and thus, the neon beam conditions (dwell time and pixel spacing) dominates the surface roughness. At the 12th scan, both of titanium and silicon signals were significantly enhanced which resulted from the matrix effect by the pronounced amounts of oxygen from the SiO₂ substrate. After the oxide layer was removed, the signal intensities dropped which can be seen in the chemical images at the 16th scan, but still we can measure the distribution of titanium and silicon at the depth of 107.6±5.6 nm after the 21st scan.

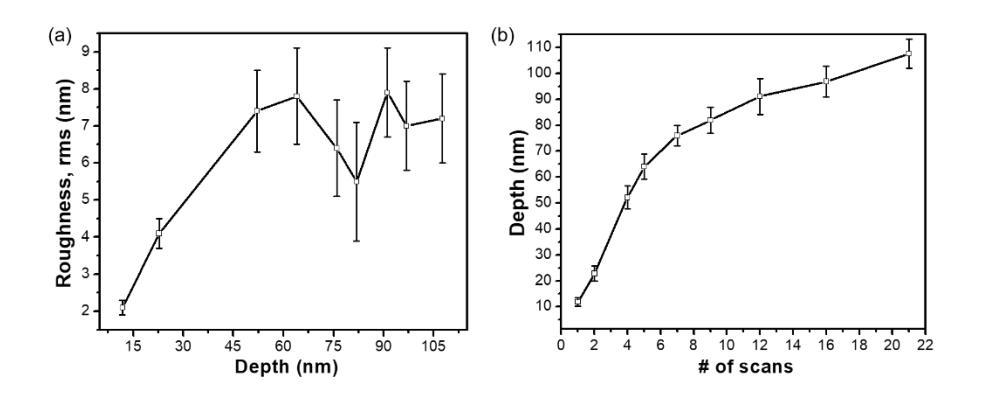
Figure S4. (a) Change of surface roughness (rms values) along the depths, and (b) the change of the depth depending on the number of scans corresponding to the total exposure time (ion doses).

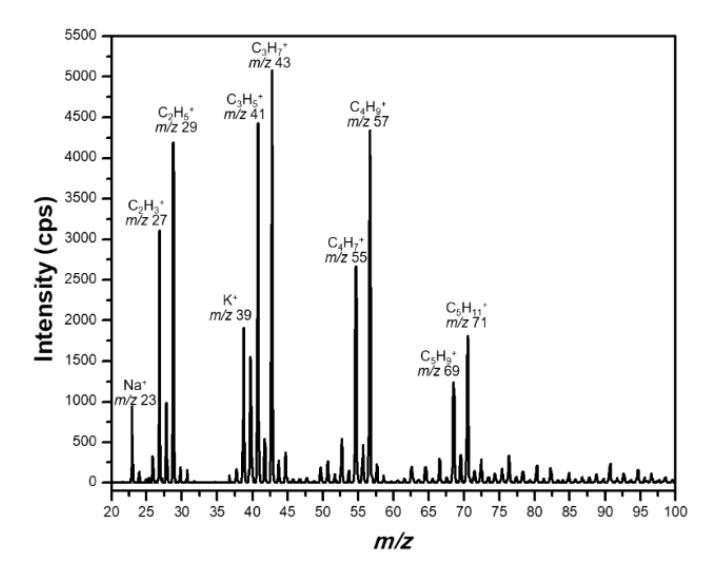
Figure S5. Mass spectrum of an epoxy sample showing the representative peaks of an epoxy sample under $m/z\sim100$ in a positive ion mode.

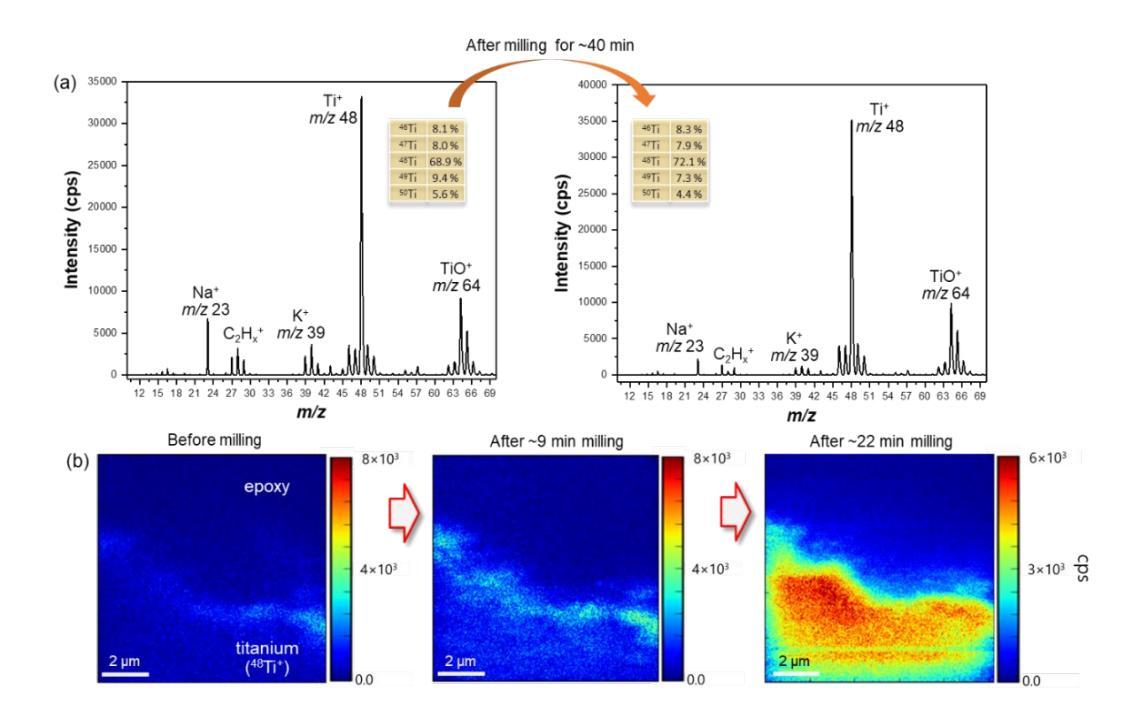
Figure S6 (a) Improved mass spectrum of a titanium after milling for 40 min and (b) chemical images (⁴⁸Ti⁺ mapping) of a titanium-epoxy interface upon consecutive imaging, inducing *in-situ* milling of surface contaminations, which made the interface far more apparent.

Figure S6(a) shows the removal of surface contamination by *in-situ* milling for 40 min to enhance the intensity of titanium peaks. Mass spectra were collected over the area of a titanium side, not including epoxy. After milling, the isotope ratios were improved closer to those of naturally occurring titanium. The removal of surface contamination in order to have accurate chemical information is visually demonstrated in chemical imaging of a titanium-epoxy interface with Ti⁺ (m/z~48) mapping. Chemical imaging was conducted consecutively, which also removes surface contaminations, and thus, the titanium signal becomes more prominent showing a very sharp interface, as depicted in Figure S6(b). The chemical imaging was done on the 5 µm × 5 µm area (1024 × 1024 pixels) with 25 keV Ne⁺ beam and a current of 50 pA. The last image in Figure S6(b) was obtained after a total milling for 22 min.

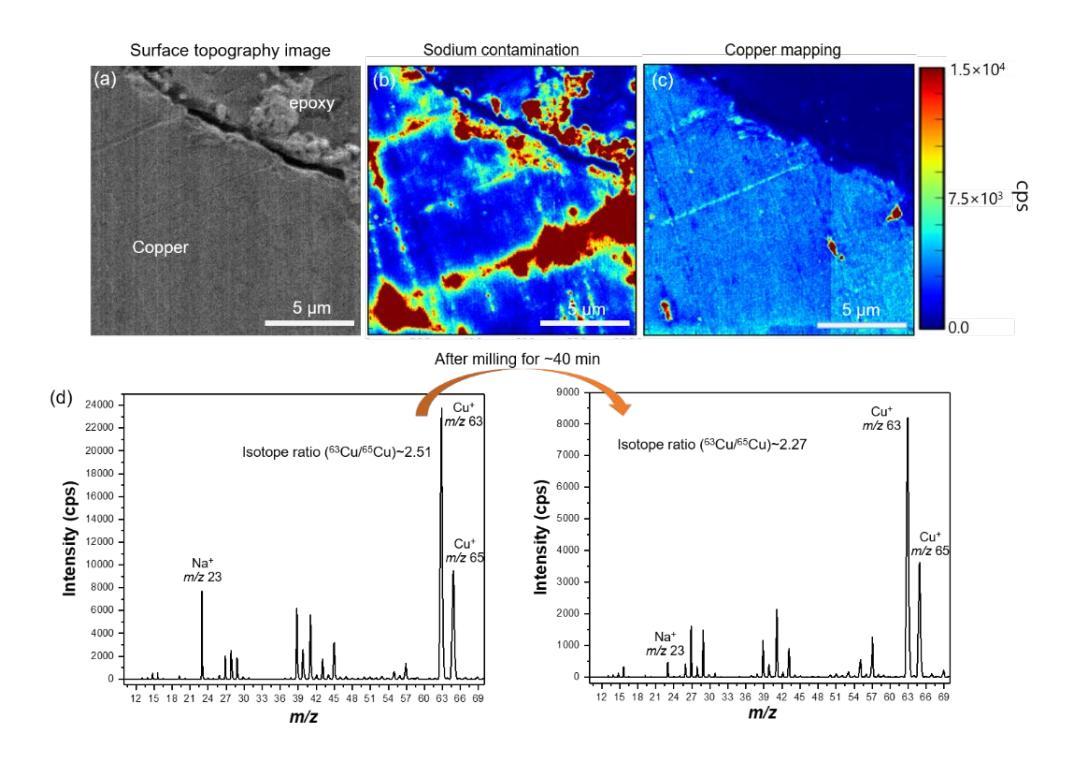
Figure S7 (a) SE topography image of a copper-epoxy interface showing no trace of surface contamination which was, however, revealed through the HIM-SIMS with (b) chemical mapping of sodium ($m/z\sim23$) providing its detailed spatial distribution, (c) chemical mapping of copper ($m/z\sim63$) showing a clear interface with epoxy, and (d) mass spectra of a copper surface before and after milling for 40 min.

Figure S7 shows chemical images of a copper-epoxy interface along with a HIM SE surface topography image. Sodium (m/z~23) and copper (m/z~63) were mapped over the interface surface. Sodium (surface contamination) distribution in Figure S7(b) was clearly identified and proven to be non-uniform over the studied surface, which could not be observed through SE signals (Figure S7(a)) due to the very thin nature of the sodium contamination. At the same time, a clear copper-epoxy interface image was obtained through a copper mapping, as shown in Figure S7(c). The chemical imaging was conducted over the 15 μ m × 15 μ m area (1024 × 1024 pixels) using a 25 keV Ne⁺ beam and a current of 3.5 pA. Figure S7(d) shows mass spectra of copper surface before and after removal of the surface contaminations. Isotopes of the copper (m/z~63 and 65) can be clearly observed in the spectra, which ratio was reduced from 2.51 to 2.27 after removing surface contaminations (milling for 40 min). This highlights the capability of the HIM-SIMS platform to provide an accurate chemical information by *in-situ* milling of surface contamination.

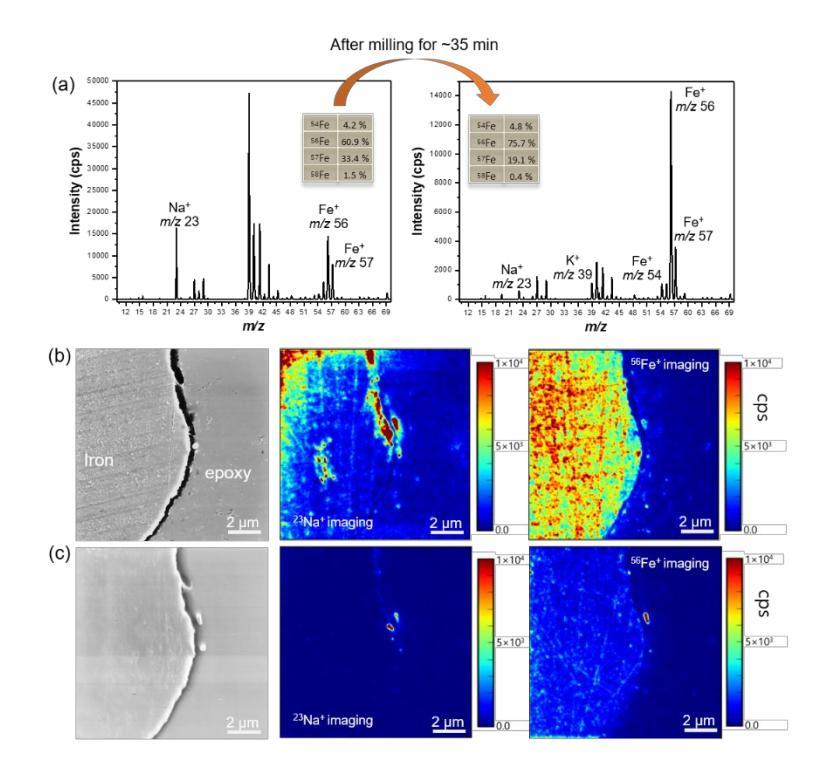
Figure S8. (a) Mass spectra of an iron-epoxy interface showing significant contamination before milling, which leads to relatively weak intensities of iron peaks with wrong isotope ratios. After milling for 35 min, iron peaks become more prominent due to the removal of surface contaminations, providing more accurate isotope ratios. Surface topography images and chemical mapping of sodium and iron (b) before and (c) after milling.

An iron-epoxy interface was analyzed first by collecting mass spectra before and after *in-situ* milling within areas of 7 μ m × 7 μ m and 1 μ m × 1 μ m, respectively, as shown in Fig. S8(a). The scanning area was zoomed into a smaller window to speed up milling of contamination. Four stable isotopes of iron can be clearly identified at *m/z*~54, 56 (primary), 57 and 58. Isotope ratios are summarized in the tables inserted in Fig. S8(a). Significant reduction of the intensity of the surface contaminations was achieved after milling for 35 min, which also significantly improved isotope ratios. An abnormally high isotope ratio of ⁵⁷Fe against 2.12% of a naturally occurring ⁵⁷Fe is due to the presence of epoxy in the analysis area (an overlapping peak of C₄H₉⁺). Figures S8(b) and S8(c) show chemical images of sodium (*m/z*~23) and iron (*m/z*~56) with SE topography image before and after milling for 15 min. Sodium distribution can be identified through chemical imaging, although, it cannot be imaged in the SE topography image. High intensity of iron can be due to iron particles and rough surfaces which can be seen in the SE image. After milling, sodium was totally removed, and the iron surface was flattened, showing an apparent interface with epoxy.

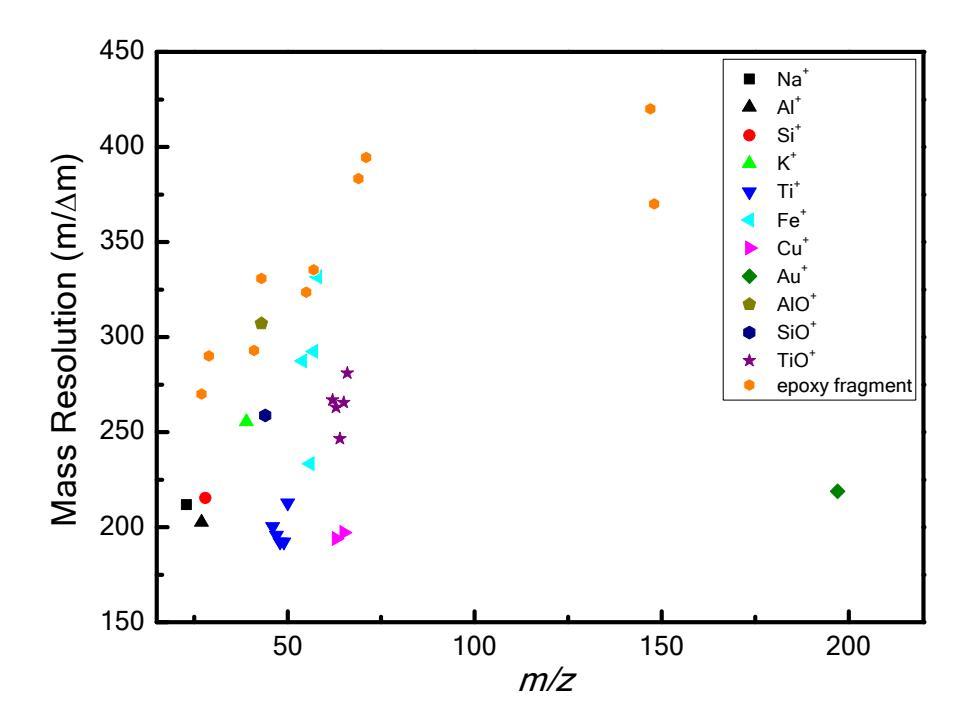
Figure S9. Mass spectral resolution of the HIM-SIMS for the peaks of various elemental ions and molecular fragment ions.

Using the spectra obtained in this study, we estimated mass resolutions $(m/\Delta m)$ depending on elements and molecular fragments as plotted in Figure S9. It shows the trend that the mass resolution for elements is almost 200 more or less, regardless of mass, except for iron $(m/\Delta m \sim 330)$. Mass resolution of hydrocarbon molecular fragments from the epoxy sample increases with mass, showing higher mass resolution than a similar mass of elemental ions. It may be due to a larger size of molecular fragments which results in their more directional flow induced by a magnetic field. Elemental ions are more prone to the Brownian motion dominance which can lead to scattering of ions and broaden a peak. The highest resolution in this study was 420 for an organosiloxane peak ($m/z\sim147$).
