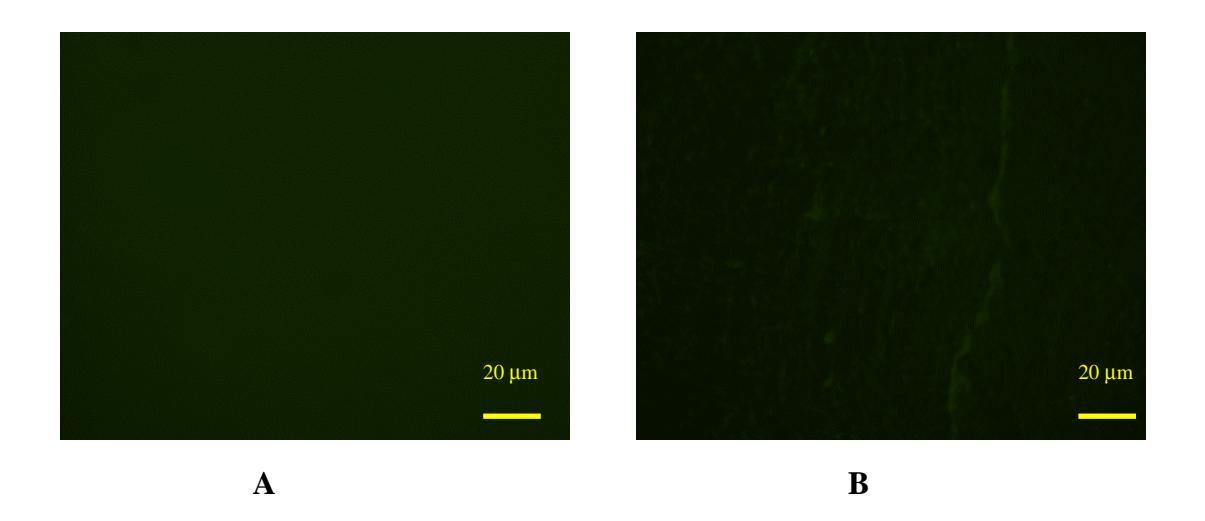
1. Examples of control fluorescence micrographs. The images show that GAGs are not or are minimally absorbed to the glass substrates during the deposition process as evidenced by the lack of a pattern. The background fluorescence observed results from non-specific adsorption of the antibodies during the staining process. A) 40X epifluorescence microscopy image of a glass control APTES surface prepared without the presence of GAG in the reactions but performing the rest of the sequence. The fluorophore used was DTAF. B) 40X epifluorescence microscopy image of a deposition of GAGs without the use of NaBH₃CN. Absence of GAGs on the glass surface or absence of the cyanoborohydrade in the reaction do not produce any visible pattern.

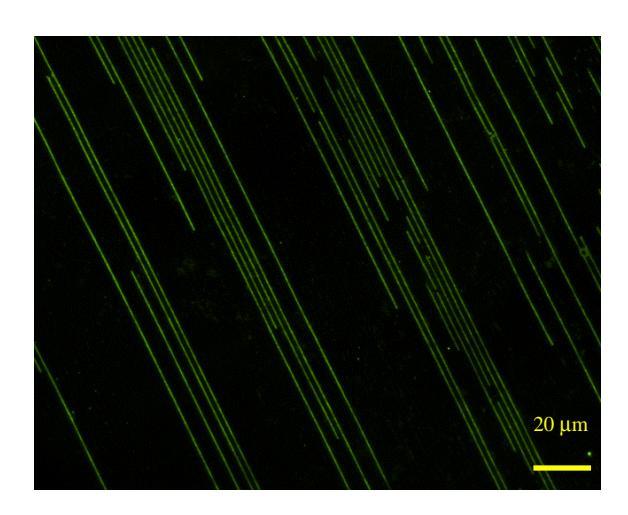
2. This image shows one pattern obtained in the early stages of the work and before improving the technique. This picture can be compared to the ones in Figure 3. As is clearly visible, a susbtantially lower number of patterned lines were transferred to the glass substrate. The image is a 40X epifluorescence micrograph of keratan sulfate with DTAF labeled streptavidin. Further experimentation permitted a better transfer of the molecules to the glass surface.
