SUPPORTING INFORMATION

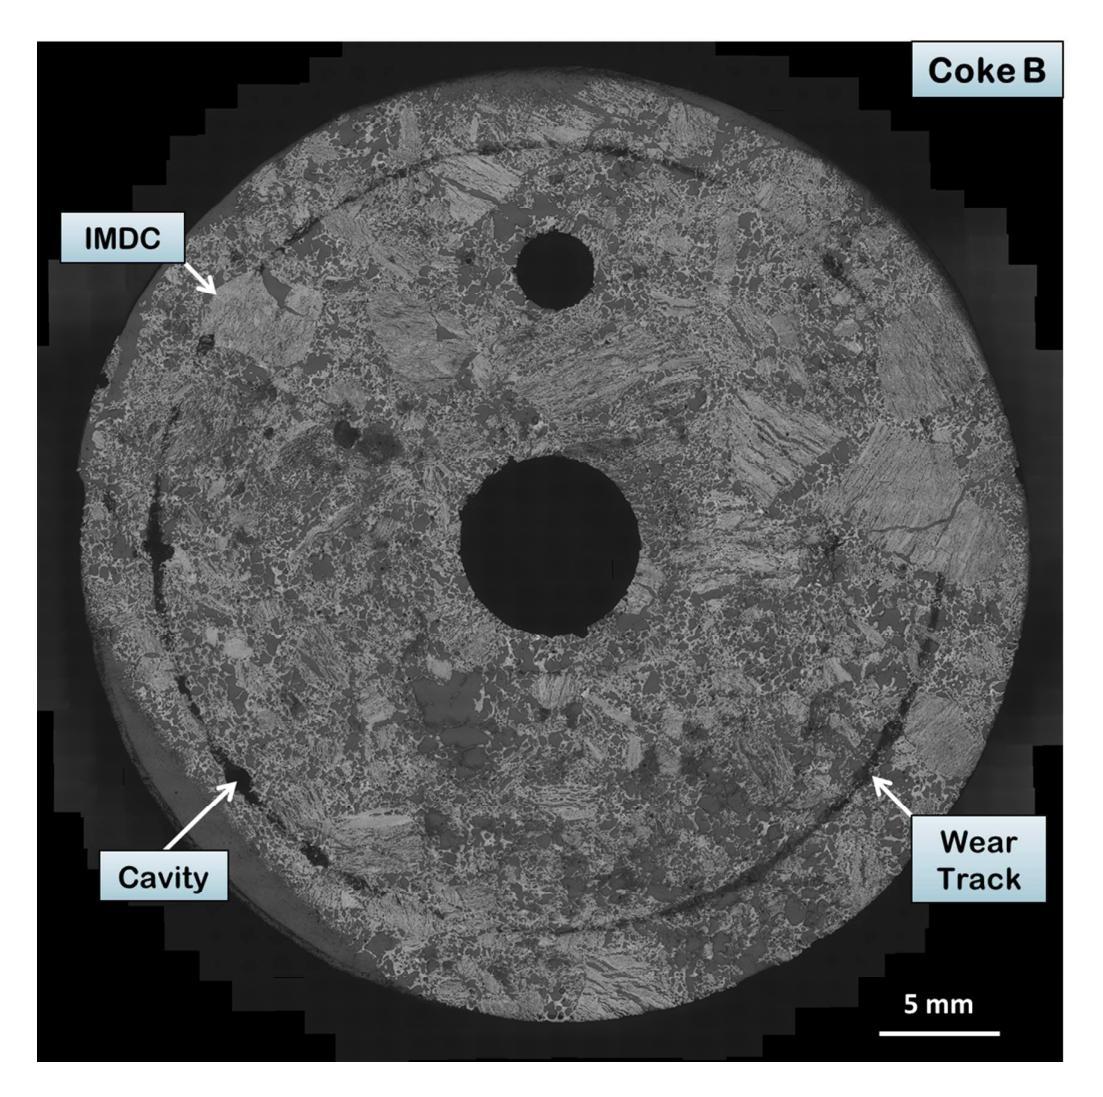
Figure S1. Optical micrograph (150 pixels per inch) of a coke B sample showing the wear track generated during tribology testing.

A high resolution optical image of the wear path generated in a coke B sample during tribology testing is shown in Figure S1 (labelled). One of the cavities, which resulted from the adhesive removal of an inert, is labelled. An inert which resisted both adhesive and abrasive wear is also labelled ('IMDC'). (N.B. The holes shown were drilled into the sample to fit the rotational stage of the tribometer.)

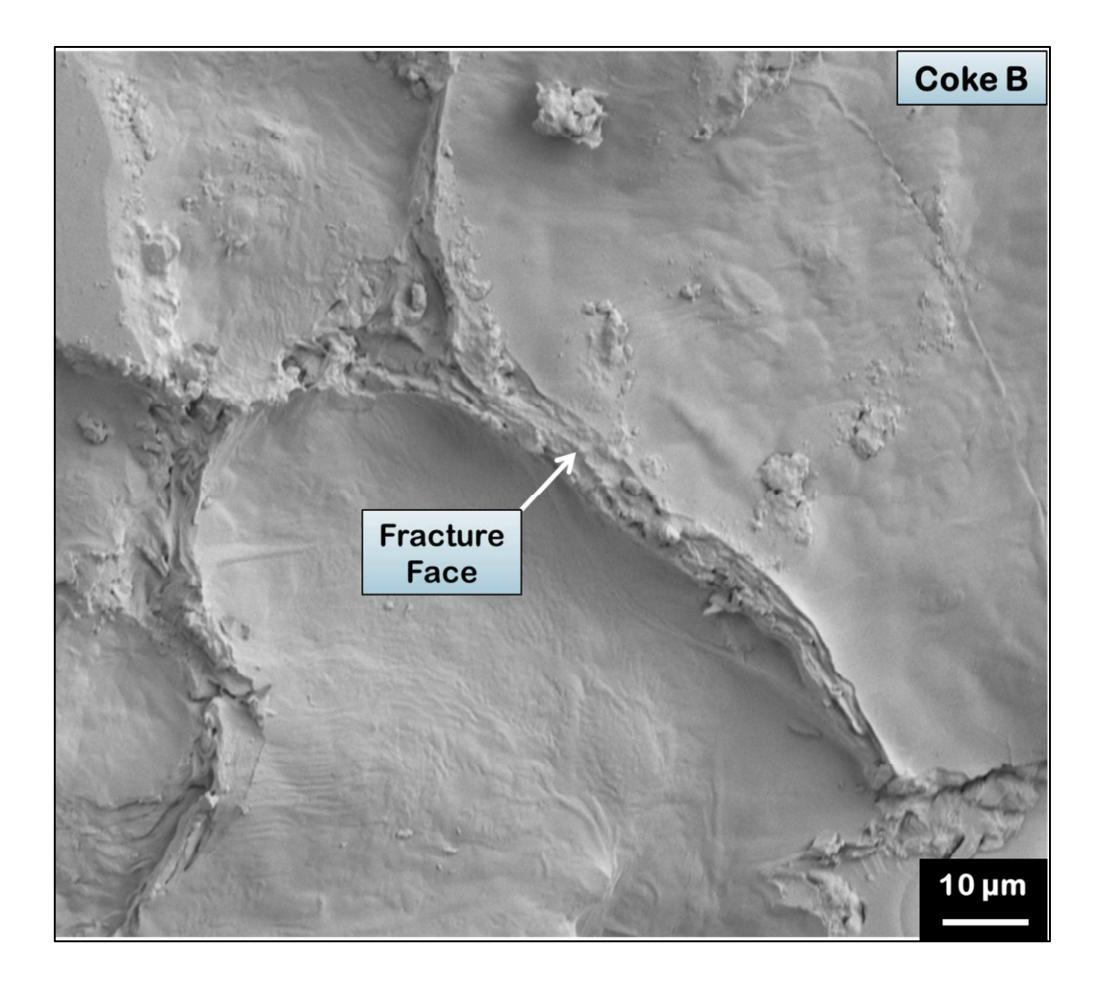
Figure S2. High magnification SEM micrograph of the floor of a cavity in a gold coated coke B sample.

Figure S2 shows a high magnification area of the SEM image shown in Figure 6, in which a cavity was generated in the microstructure of the coke B sample due to the adhesive displacement of a thin surface layer of IMDC during tribology testing. The topography of the cavity floor indicates that pores were agglomerated within a thin plate-like structure in this region. The fracture faces, such as the example labelled, suggest that there were regions where the RMDC at the cavity floor was bound to the thin surface layer of IMDC that was removed during the test, forming the cavity evident in the micrograph upon its removal.
