## Supplementary Material.

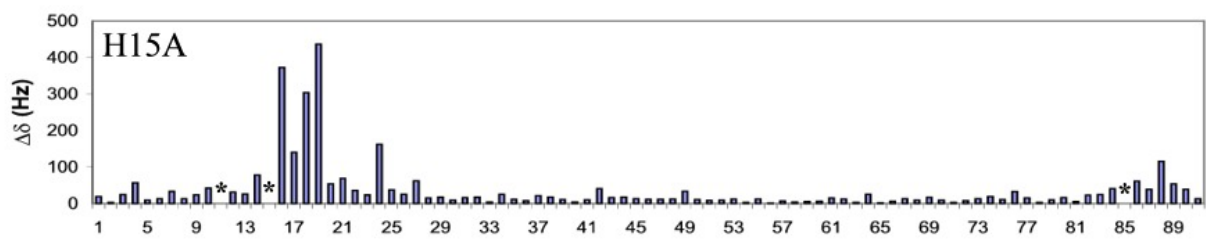
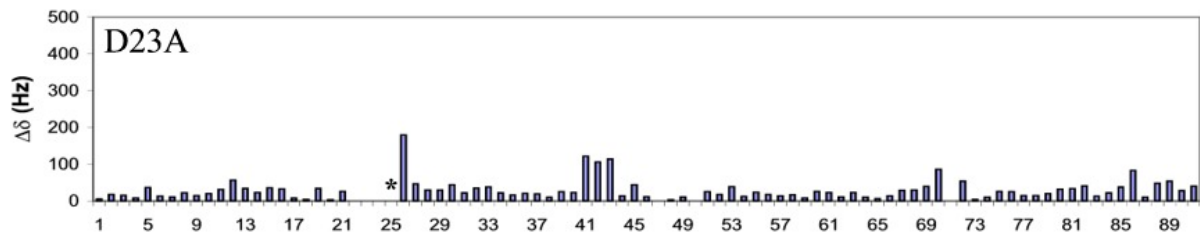
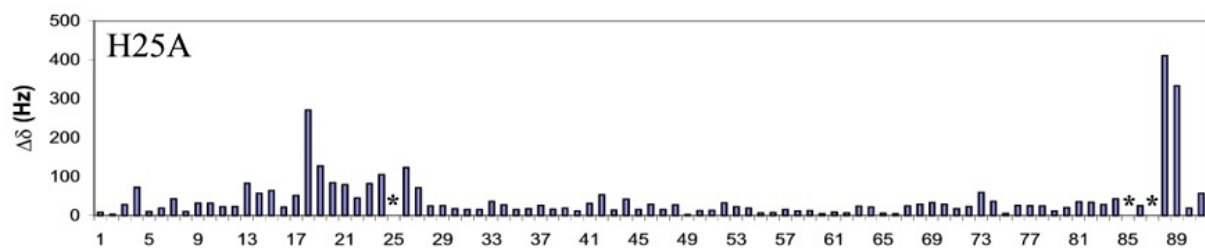
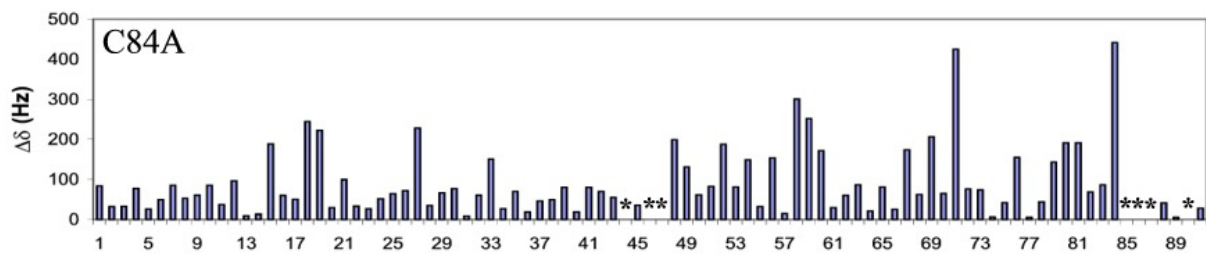
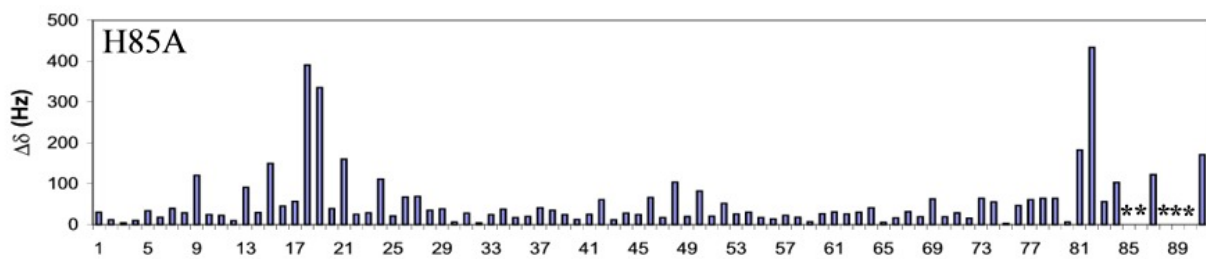
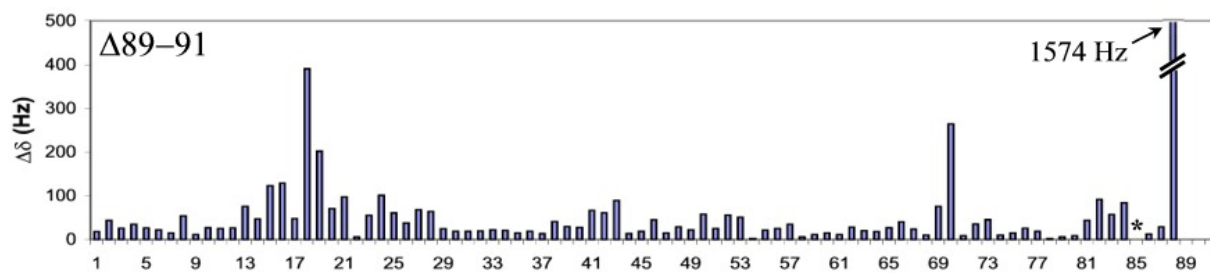
Figure 1S: Changes in combined backbone  $^1\text{H}$  and  $^{15}\text{N}$  chemical shifts of wild-type S100B caused by the H15A, D23A, H25, C84A, H85A, or  $\Delta 89-91$  mutations. Comparisons were made for apo-S100B for all of the mutations except for D23A, in which case comparisons were made for  $\text{Ca}^{2+}$ -S100B. For the most part, the mutations were found to affect only residues spatially nearby the mutation. The one exception being the C84A mutation, which had wide spread perturbations throughout the protein indicative of a larger structural change. The asterisk (\*) indicates residues for which the chemical shift values could not be determined due to exchange broadening effects due to the mutation.
